L322 STEERING LOCK PROBLEM & CHEAP SOLUTION

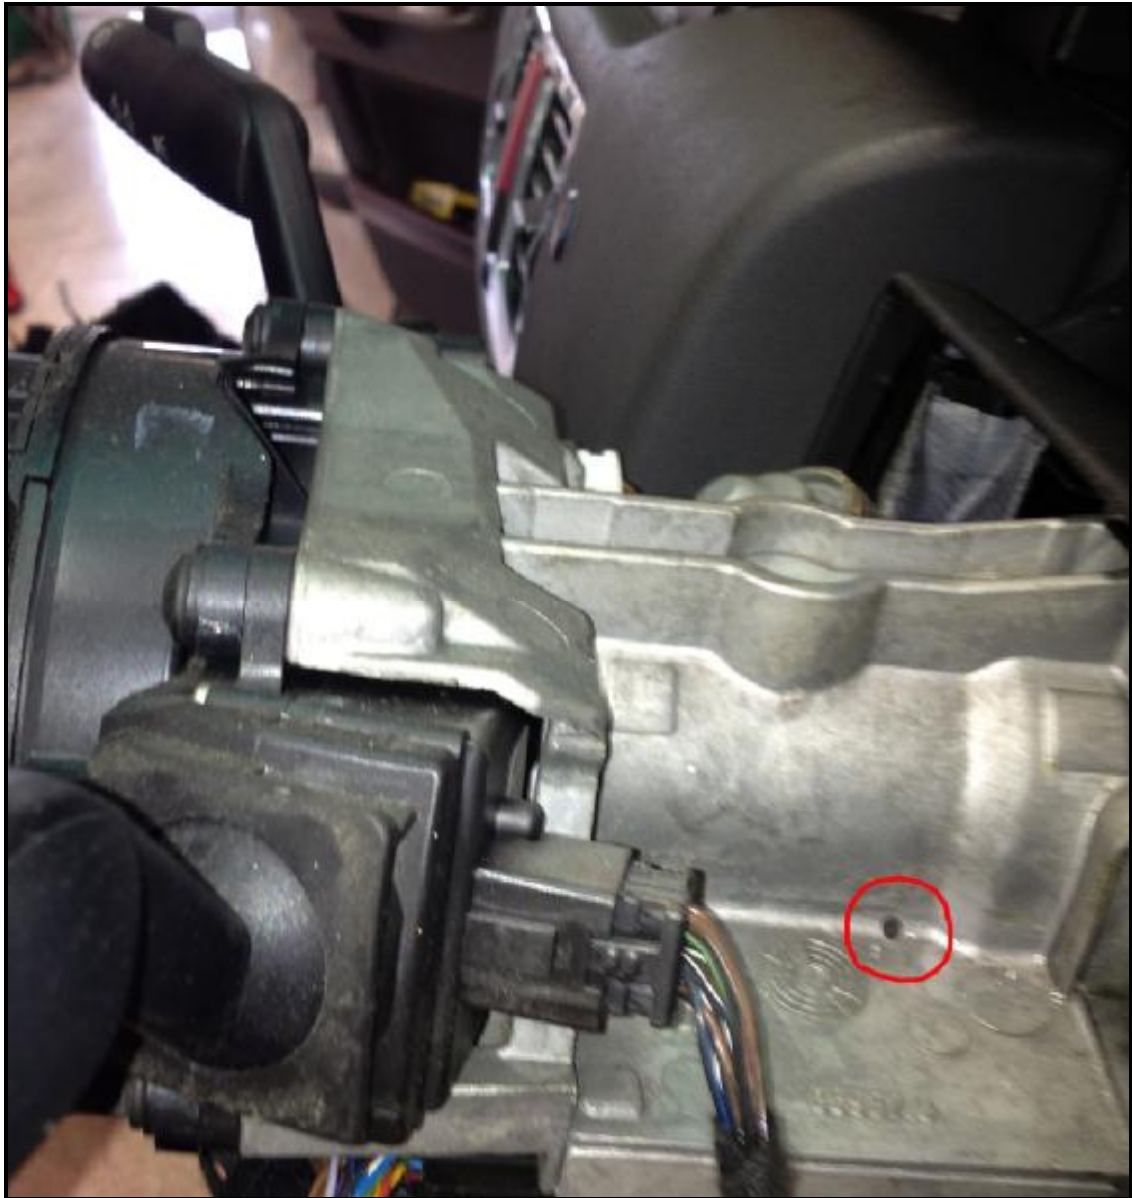
Ultimately the Steering lock ECU has a physical locking bolt driven by a motor and cam assembly that engages or disengages with the steering columns main shaft and Yiotis had discovered that this bolt was sticking.

From the exploded diagram provided in the Workshop manual it looks like the solenoid, well more of a motor and cam, actually drives the Bolt and holds it to the unlocked position. It then releases the bolt when it comes to lock it but this is then done by a spring which I guess is where the sticking bit happens.

This would account for why you can turn the key in the barrel the first time only, as the Immobilizer ECU which controls the barrel key turn lock solenoid as well as the Steering lock ECU from which it gets confirmation feedback would upon seeing the key turned for the first time send an Unlock command to the steering lock ECU and get feedback that the bolt was now in the unlocked position. Then on first turn off it would then send a lock command to the steering lock ECU but due to the sticking Bolt would not get a confirmation reply of the bolt moving to the locked position, causing it to store a communication fault and no longer allow the Key to turn.

Here is the picture of the location the hole has to be drilled in, circled in Red

The solution was simply to apply further lubrication to the mechanism to allow it to work freely. However Yiotis also figured that this could be done without removing the Steering Lock ECU from the vehicles Column as for security this is mounted in a way that would make it very difficult.

Yiotis figured roughly where to drill a small 2mm hole in the main column's upper aluminum casting through which he could insert the small straw that comes with cans of WD40 and then spray some in.

I guess the location, drill size or angle is not that critical, and I also have to guess that you just drill till you break through. Perhaps it would be wise to go slow such that the drill removes all Swarf though.
